Senior Project

Process Validation of IACV screw

Man (Eric) Ng Submitted Dec. 01, 2023

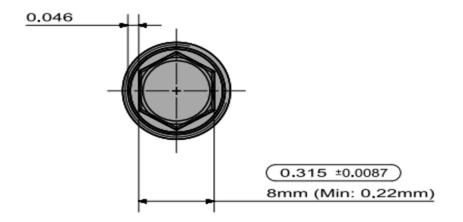
Figure 3 - CN 1 Hex head of IACV Screw

CN (Critical Number) 1 is the head of the screw as shown below in *Figure 3*. This was an 8mm hex head machined into the screw, which was needed to fit a socket or nut driver to adjust the screw. According to Fast-rite page 38, the tolerance for an 8mm hex head is 0.22mm which converts to 0.0087 inches. This was a crucial part to fit different brand/manufacturers of an 8mm socket, which is why it is crucial to use industry standards with dimensioning this hex head. All screws were within the limits, but there were more than half below the spec and closer to the LSL which does not mean the screw does not work. The hex head would be slightly loose when a socket or nut driver is being used, but since the amount of torque needed to turn this screw is not very high this would not cause the screw to strip. In addition to measuring all six sides of the hex; the hex head was checked with a combination wrench, sixand twelve-point socket, and a six-point nut driver. The C_P for this is 1.279, which is okay but not good since it is above 1. With the C_P for CN 1 above 1 which it means it is not capable or centered. C_P is calculated with $\frac{USL-LSL}{6*Std.dev}$. The C_{PK} is -0.965 which is not ideal for the C_{PK} ideally it should be 2 or higher.

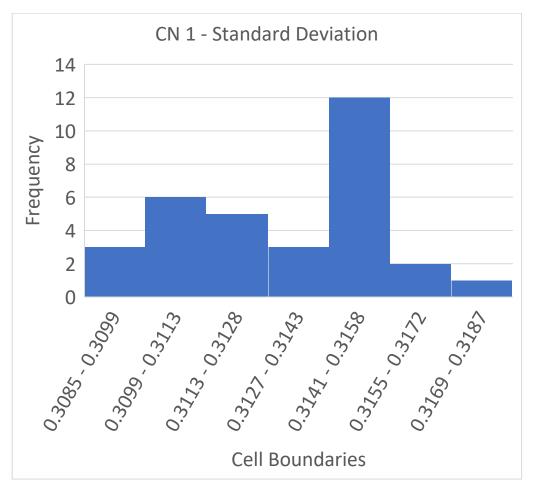
Figure 4 - CN 1 Standard Deviation

C_{PK} USL is calculated with $\frac{Z USL}{3}$ and C_{PK} LSL is calculated with $\frac{Z LSL}{3}$. Figure 4 shows the standard deviation of CN 1, this chart shows where the measurements are with dispersion in relation to the mean or average of the dataset. In Figure 5, this shows where exactly each part falls within the specification and tolerance (USL (Upper spec limit) and LSL (Lower spec limit)). There are sixteen parts out of thirty that are below the specification limit, which is still technically within tolerance, but it is not ideal. In testing with a combination of a combination wrench, six- and twelve-point socket, and a six-point nut driver; the parts that are still functional in its ability to turn the hex head.

CN 1 Data	
Min	0.30850
Max	0.31700
Range:	0.00850
n:	30.00000
mean	0.31286
mode	0.31500
Std dev.	0.00227
Sturgis' Rule	
i:	0.00144
h:	6.00000
Tolerance:	0.009
Spec	0.315
USL	0.324
LSL	0.306
Ср	1.279850081
Std. dev	30.26023805
C ⁴	0.9914
Z USL	4.78350
Z LSL	-2.89560
CpK USL	1.594500325
CpK LSL	-0.965199838
X-bar	0.312861111

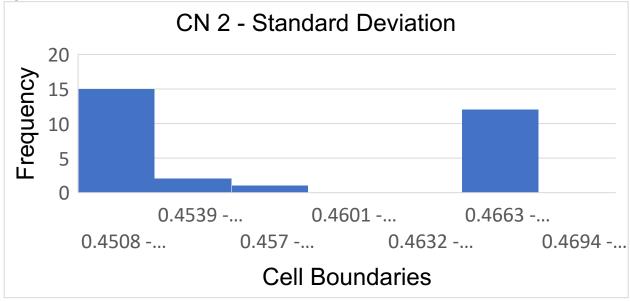
Figure 7 - CN 2 Standard Deviation

CN 2 is the threads of the screw this is a metric M12x1 as shown below in Figure 6. The threads were checked using the 3-wire measuring method to get the more accurate reading. This includes selecting the correct wire diameter for this thread pitch. It requires a wire diameter of 0.023'' or 0.58mm. A steel welding wire was used with this diameter and a measurement of the wire was taken to ensure correct wire dimensions. This welding wire measured 0.02255'' which will work for this application. All the dimensions are within the spec limits, but there are eleven parts right on the line of the LSL which were not to the ideal measurement for the parts should be. The C_P for CN 2 is 1.227 which is okay, but since the actual dimensions are still on the lower bound of the graph this process will need to be improved on. The C_P should be at 1 ideally, with the C_P for CN 2 above 1 which means it is not capable. The C_{PK} for this is -0.325 which is not ideal for the C_{PK} ideally it should be 2 or higher. Which means the C_{PK} is falling short and outside of scope.

Range:	0.01845
n:	30.00000
mean	0.45924
mode	0.45185
Std dev.	0.00815
Sturgis' Rule	
i:	0.00312
h:	6.00000
Tolerance:	0.030
Spec	0.4813
USL	0.511
LSL	0.451
Ср	1.227291073
Std. dev	30.26023805
C ⁴	0.9914
Z USL	6.38969
Z LSL	-0.97406
CpK USL	2.129895475
CpK LSL	-0.324686672
Xbar	0.459236667

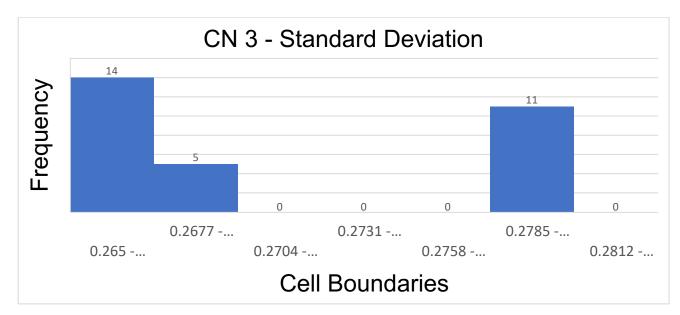
Figure 10 - CN 3 Standard Deviation

CN 3 is the groove where an o-ring will be installed as shown in Figure 9. This groove is shown below in Figure 9. This groove was measured with digital calipers. The tolerance of this groove was determined from the use of an o-ring design guide from Parker Hannifin. The guide specifies there is only an allowance in the USL (Upper spec limit) and for LSL (Lower spec limit) will be the dimension the screw is drawn to. Which mean anything that falls below the specification of 0.28" in this case will be out of spec and would be deemed as scrap or not useable. The diameter of this groove is an important because of the surface areas of where an o-ring and the groove meets is crucial for sealing of the screw to this valve itself to allow correct adjustment of air flow. The standard deviation is skewed to the left is not centered and was below the tolerance as shown in Figure 10. Out of the thirty parts there were twenty-three that are out of tolerance as shown in Figure 11. The C_P CN 3 is 0.053 which is far below one. The C_{PK} for this is 0431 which is not ideal for the C_{PK} ideally it should be 2 or higher. Which means the C_{PK} is falling short and outside of scope. This part of the screw is not in tolerance since there are more part that were out of tolerance and consider scrap.

1	
mode	0.26700
Std dev.	0.00627
Sturgis' Rule	
i:	0.00271
h:	6.00000
Tolerance:	0.002
Spec	0.280
USL	0.282
LSL	0.280
Ср	0.053180296
Std. dev	30.26023805
C ⁴	0.9914
Z USL	1.61402
Z LSL	1.29494
CpK USL	0.538007333
CpK LSL	0.43164674
Xbar	0.271883333

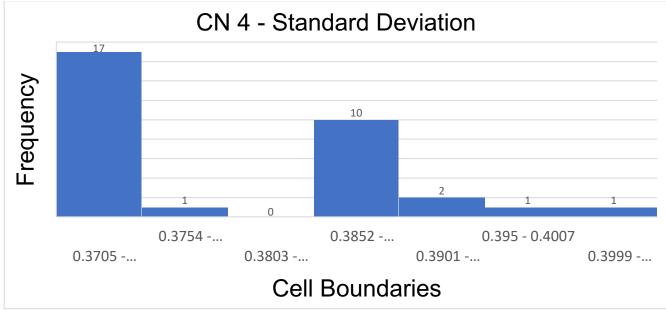
Figure 13 - CN 4 - Standard Deviation

CN 4 is the "piston" of the screw this is the bottom of the screw as shown in Figure 12, and this is the part that cups the air to the valve to adjust for idling of the engine. There are eleven parts that are in tolerance and there are nineteen parts that are out of tolerance with one that is above tolerance and the rest under as shown in Figure 14. In Figure 14, it shows the Standard Deviation is skewed to the left and not centered. The $C_P CN$ 3 is 0.172 which is far below one. The C_{PK} for this is 0.049 which is not ideal for the C_{PK} ideally it should be 2 or higher. Which means the C_{PK} is falling short and outside of scope. This part of the screw is not in tolerance since there are more part that were out of tolerance and consider scrap.

h:	6.00000
Tolerance:	0.005
Spec	0.386
USL	0.391
LSL	0.381
Ср	0.171955064
Std. dev	30.26023805
C ⁴	0.9914
Z USL	1.17961
Z LSL	0.14788
CpK USL	0.393203913
CpK LSL	0.049293785
Xbar	0.379566667

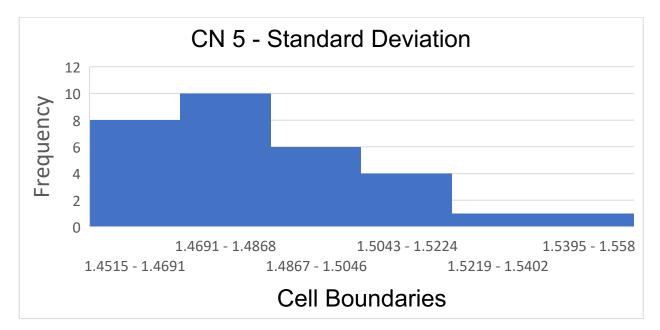
Figure 16 - CN 5 - Standard Deviation

CN 5 is the overall length of this part. This was a crucial part since if the length is too short this would not work and would be too far down into the valve and it would be not adjustable. The extra length of this part was designed into the length of the hex head and the rest of the screw is not affected by the extra length. During designing of this part this was the intent to allow for more length on the hex head for extra grip of the socket head as shown in Figure 15. In Figure 16, the Standard Deviation is skewed to the even though the parts are within the limits, but the parts were in the lower in the specification. Where the parts fall within the measurement is shown in Figure 17. All thirty parts all fall very close to the Spec and LSL this was controlled from manually parting off the part. The $C_P CN 3$ is 1.577 which is ideal and means this was somewhat in control. The C_{PK} for this is 2.678 which is ideal for the C_{PK} ideally it should be 2 or higher.

LSL	1.450
Ср	1.577235173
Std. dev	30.26023805
C ⁴	0.9914
Z USL	8.03521
Z LSL	-1.42821
CpK USL	2.678401987
CpK LSL	-0.476068359
Xbar	1.48565

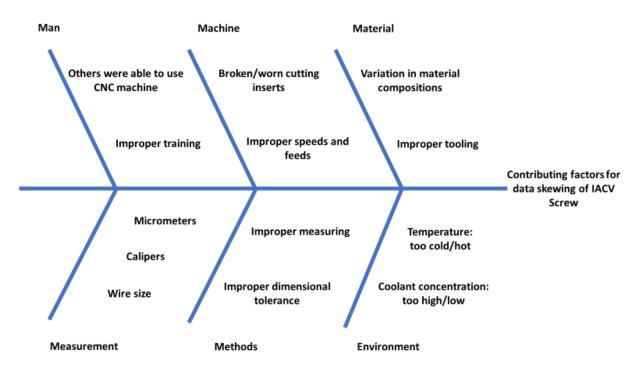
Figure 18 - Fishbone Diagram of Assignable causes

The data retrieved shows the process is not in control with critical dimensions 2-4. The fishbone diagram (shown above in Figure 18) illustrates some assignable causes which could cause errors in the parts. Due to these assignable causes some parts have failed quality check as shown in X-bar & R Chart (as shown in Figure 5, 8 11, 14, and 17) it shows how there are parts that fall below spec (green line). This does not make the part scrap, but it is not ideal. The parts are completed, but the process will need to be improved on before moving forward into a manufacturing setting.

To revalidate this part there will need to be more control set in place and using the Fishbone diagram shown above in Figure 18 as the checklist as to what could be controlled. These assignable causes will be checked off one by one to mitigate each of these possible causes. Tool wear was most likely a big contributor to the dimensions not being in spec. Tool wear is impossible to spot with just eyes alone each part will would need to be checked as the machining is happening and tool wear would need to be adjusted as the parts were being machined. Next, would be a complete revalidation with assignable causes as the limit for each part that would be double checked to prevent scrap parts being produced.

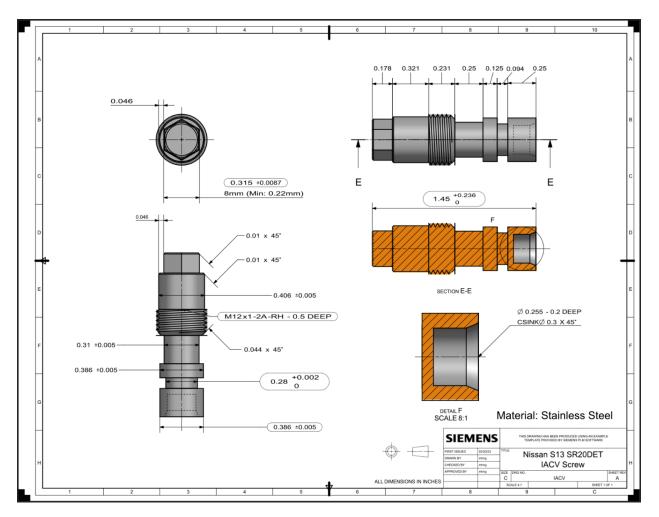
Appendix B – Detailed Drawings (as needed)

This screw was designed originally by taking measurements of the original plastic screw which was part of the IACV assembly. After taking the measurements, they were used to create CAD model as shown in Figure 1 above. During the manufacturing of the screws there was a setback; the school where the CNC and manual machines was shut down for summer break. The screws were made to the print shown in Appendix B. Tolerances were determined using design guides from Parker and Fast-Rite. When proofing out the CNC program the chuck of the CNC lathe was not adjusted correctly and was loose when it was clamping on the round stock. This was not noticed until eleven parts had been made and the CNC program was already proofed out. The chuck was readjusted to ensure the round stock would be clamped tightly and it would not move during the machining process. There was no real deviation from the original technical plan. After the screws were all machined, each critical dimension was checked to the print shown in Appendix B using a digital caliper and micrometer.
